Affecting A-30 altitude encoders to serial number 23849

November 11, 1989

Modification of the A-30 to MOD 2 status

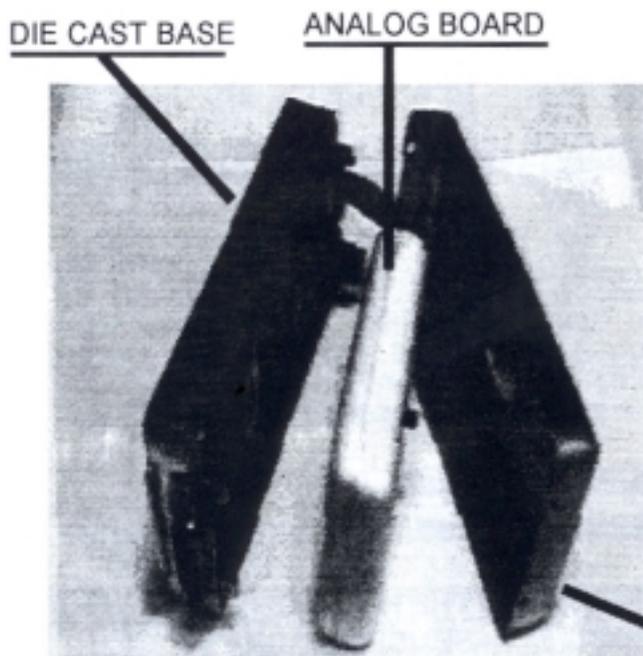
FIGURE 1

1. Remove the A-30 top cover by removing the four retaining screws which affix it to the die cast aluminum base. (see figure 1)
2. Remove the analog board assembly by disconnecting the 10 pin plug located at the end of the ribbon cable from the main board assembly.

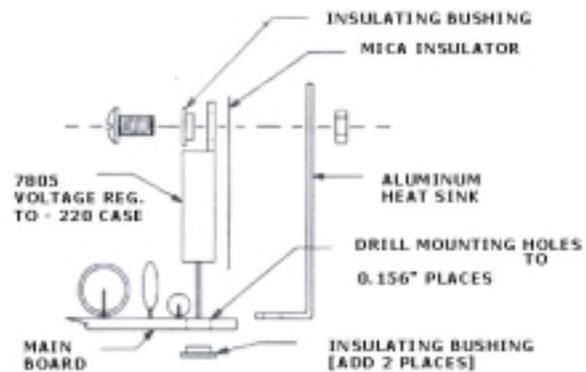
FIGURE 2

The following procedure describes Modifications which may be done in the field to bring earlier serial numbers to MOD level 2. This MOD need only be done on units where a ground loop problem as described in our service bulletin a-30-1 is encountered.

4. Remove the screw which attaches the voltage regulator heat sink to the voltage regulator. (see figure 2)
5. Using a 5/32" drill enlarge the two main board attaching screw holes pi (see figure 2) making sure that the drill removes all of the conductive trace material between the upper and lower layer of the board. If any conductive material remains in the hole remove any remainder with a bearing scraper or exacto knife.

6. Reassemble the unit installing the insulator bushings and mica insulator as shown in figure 2. A non conductive grease or adhesive may be used to hold the insulator bushings in place during assembly.
