AFFECTING MODEL A-30 ENCODERS TO SERIAL NUMBER 38567
JUNE 12,1990

TO: ALL A-30 ALTITUDE ENCODER DISTRIBUTORS
PLEASE PROVIDE COPIES OF THIS LETTER
TO ALL INSTALLING DEALERS
RE: MODIFICATION OF THE A-30 TO MOD 3 STATUS

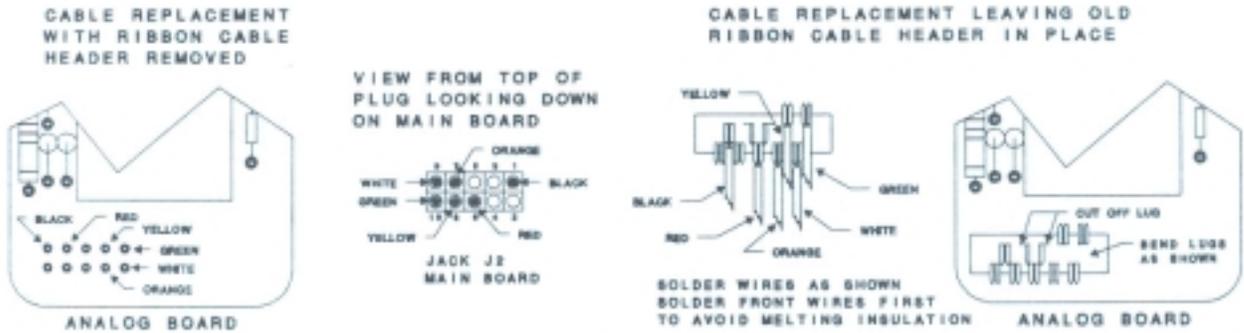
Important check the cable for proper wire color position against the drawing below before installing.

1. If de soldering equipment is available de solder the ribbon cable header from the analog board assembly and solder the new cable assembly as shown below.

2. The cable may be replaced without de soldering by removing the ribbon cable header retaining cover and pulling the ribbon cable off of the header. Cut the two lugs on the header and bend the remaining lugs as shown below. Solder in the new cable assembly as shown below.

Plug the analog board assembly back in to the main board as shown below. Replace the top cover and re calibrate the unit.
